SS EDGAR M. QUEENY - S/T CORINTHOS; COLLISION
AT MARCUS HOOK, PENNSYLVANIA ON 31 JANUARY 1975
WITH LOSS OF LIFE

U.S. COAST GUARD
MARINE BOARD OF INVESTIGATION REPORT
AND COMMANDANT'S ACTION

ACTION BY
NATIONAL TRANSPORTATION SAFETY BOARD

REPORT NO. USCG/NTSB MAR-77-2
RELEASED

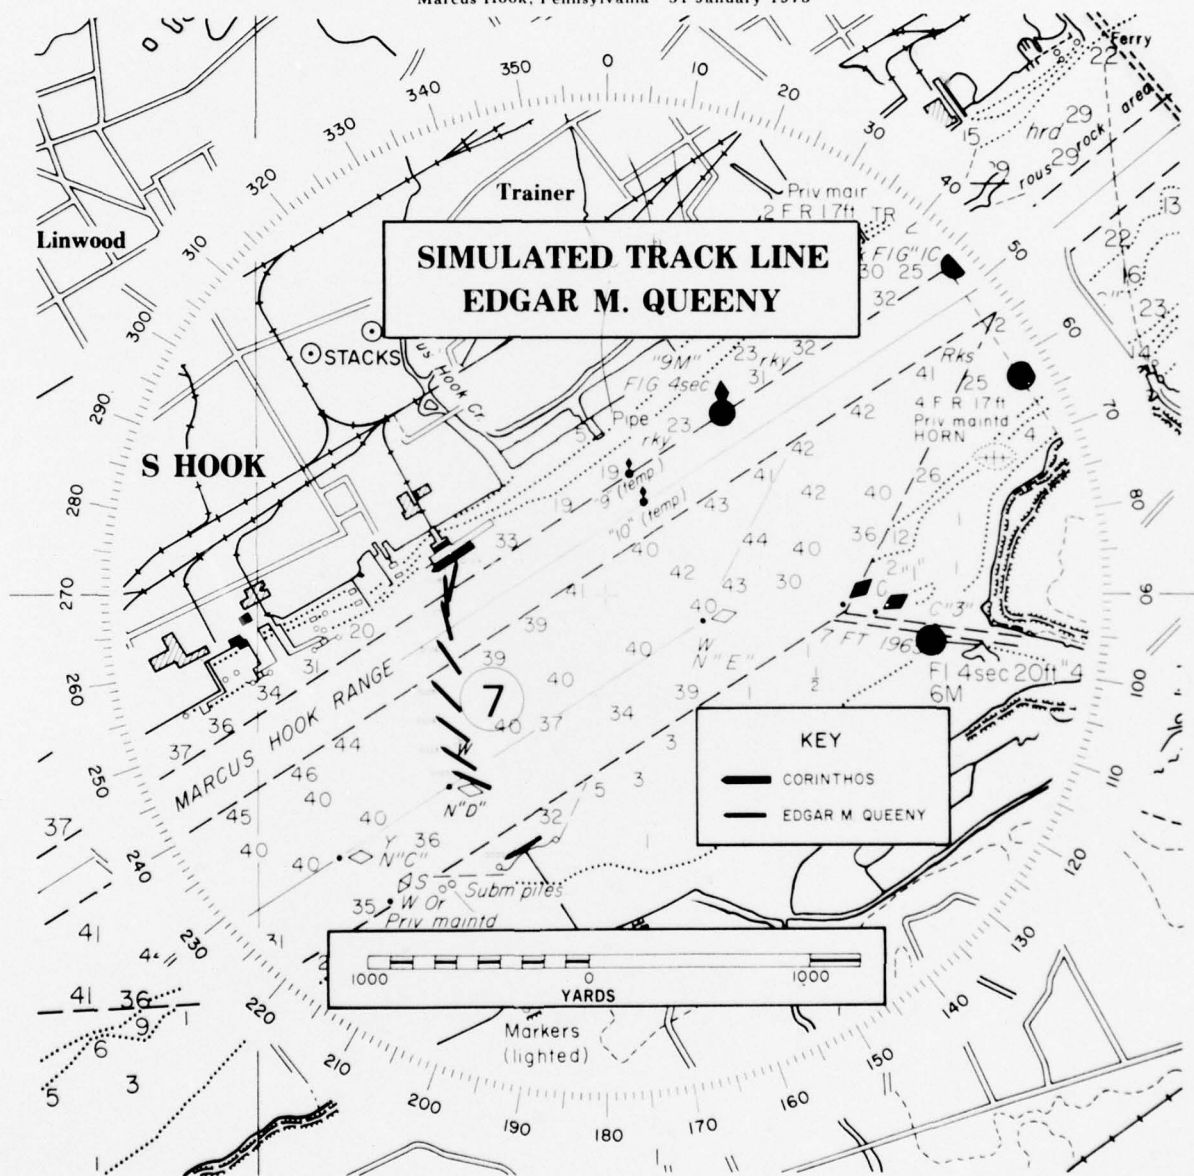
**COAST GUARD MARINE
BOARD OF INVESTIGATION
S/T CORINTHOS / SS EDGAR M. QUEENY COLLISION**
 Marcus Hook, Pennsylvania 31 January 1975

37. During the preparation of Figure 1 appended hereto, the Board determined that the EDGAR M. QUEENY rudder was hard right at the time that the vessel struck the CORINTHOS. The Board recognizes that this presumption conflicts to some degree with the testimony of the Helmsman Mr. Sutton. One part of Mr. Sutton's testimony alternately indicates that he observed the rudder amidships at or before the time of collision. Comparing the description of one of his observations with other events it is obvious that he was describing a condition that existed for several minutes before the collision. Repeated questioning by Board members, and others participating in the hearings, also elicited from Mr. Sutton an acknowledgement that the observation could have been made after the collision. The Board chose to discount his testimony regarding this point since it could not be corroborated and because of his tentative and contradictory accounts.
